C2R-FRD1 Tech Brief

Fix For:
“No Audio when using the C2R-FRD1”

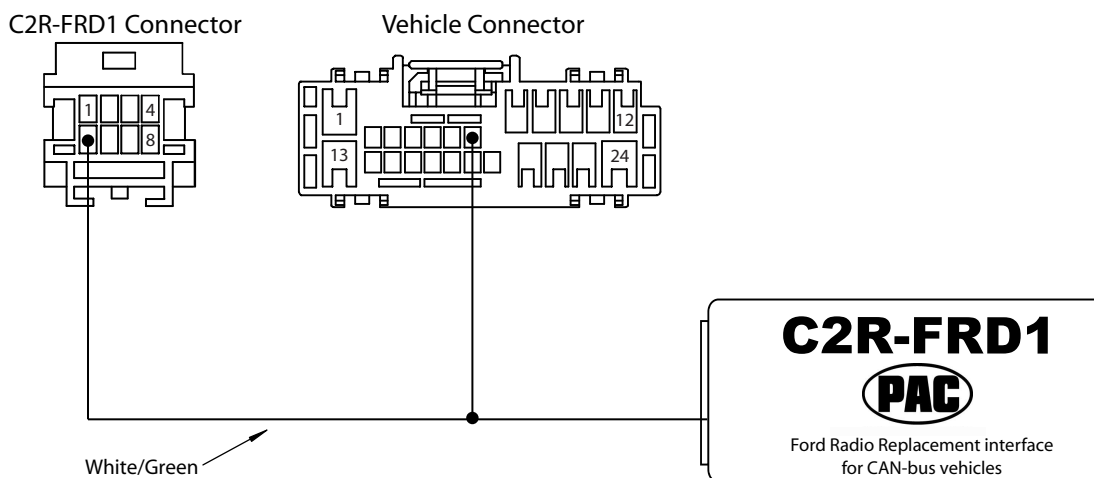
1. Locate the 24 pin main power harness in the vehicle.
2. Locate the Yellow/Purple wire in pin 7 of the main power harness in the vehicle.
3. Connect a jumper wire from the Yellow/Purple wire in the vehicle harness to the White/Green wire which connects from the C2R-FRD1 module to the 8 pin sub connector.

Connectors are viewed from wire side
