Pacific Accessory Corporation

-Displaying video on far rear screen in applicable vehicles

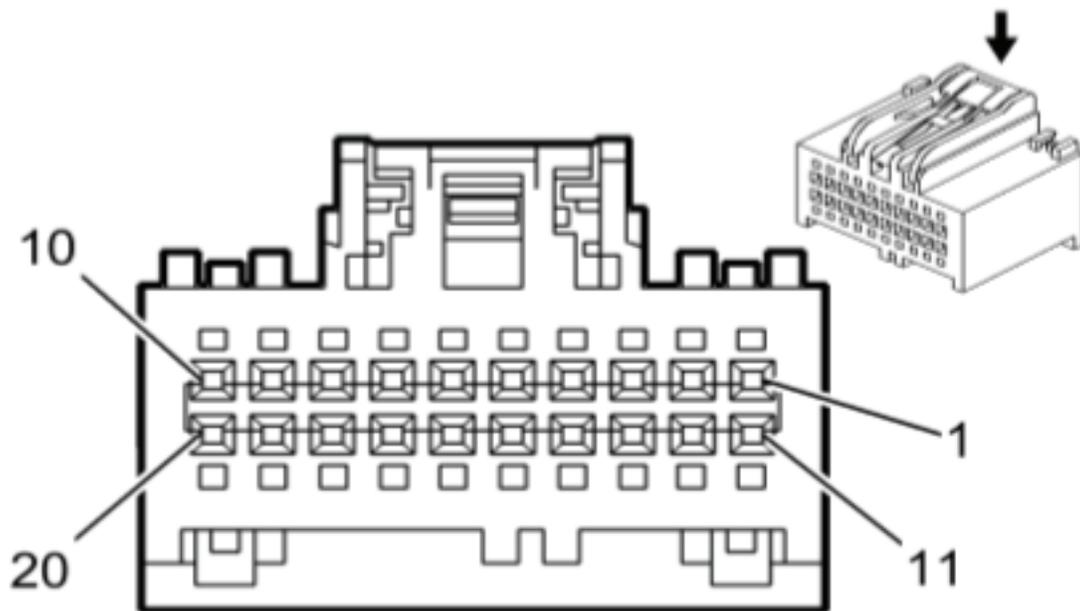
Solution: Below is a picture of the connector in which four wires need to be connected for video to be displayed on the far rear screen. For reference this is the male connector on the GMRVD2 harness and the pin view is from the wire side (see image with arrow for reference).

Pin 8 - Lt. Green - Screen 2 Video +
Pin 10 - Green/Black - Screen 1 Video +
Pin 18 - White - Screen 2 Video -
Pin 20 - White/Black - Screen 1 Video -

Pin 8 needs to be spliced with Pin 10

Pin 18 needs to be spliced with Pin 20
