This technical bulletin only applies to RPK4-FD2101 kits that have harness with label FD2A-RS-HAR included.

Factory USB port is no longer powered or functional upon removing the factory radio.

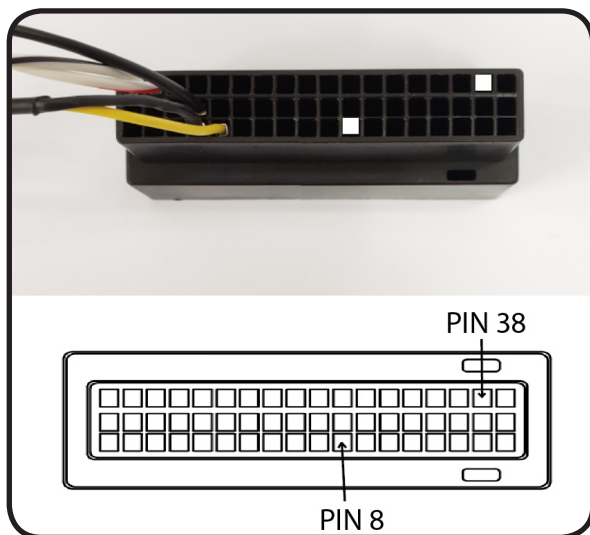
STEP 1

IDENTIFY THE RECEPTACLES YOU WILL BE ADDING PINS INTO ON THE 54-PIN CONNECTOR.

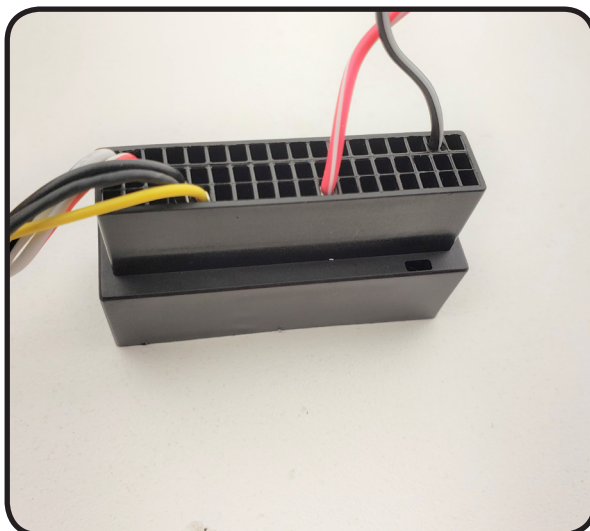
STEP 3

ENSURE PINS ARE SEATED FIRMLY INTO POSITION. PINS WILL “CLICK” INTO THE RECEPTACLE.

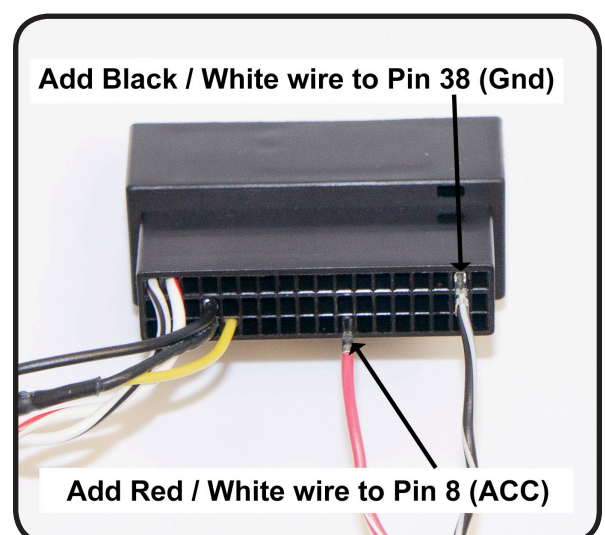
STEP 2

INSERT PINS INTO RECEPTACLES 8 AND 38 WITH LOCKING TABS FACING EDGE OF CONNECTOR.

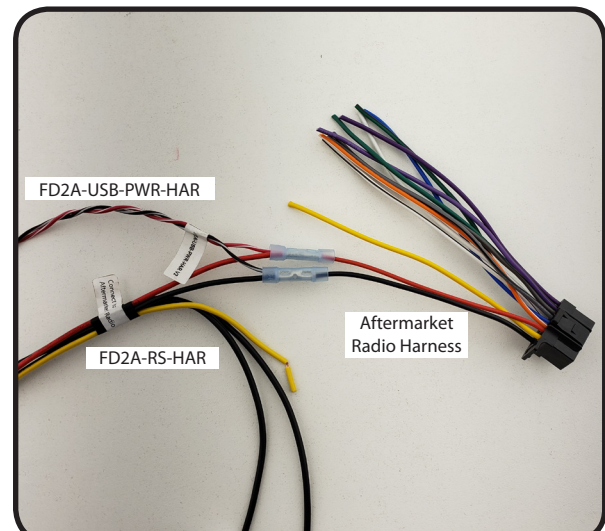
STEP 4

CONNECT LOOSE WIRE ENDS TO ACCESSORY 12V+ AND GROUND AT AFTERMARKET RADIO HARNESS.
